## CYLINDER HEAD GASKETS MORRIS EIGHT 1934-38

### A few observations following recent discussions regarding localized overheating.

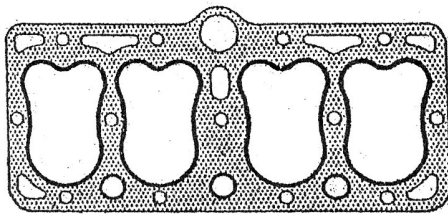
**Morris Eight Series I/II**

All UB type cylinder heads were manufactured with a water passage between cylinders 2 and 3, but none near the distributor hole area. Regarding later type cylinder heads, these appear in all cases to have been manufactured without the water passage between cylinders 2 and 3, but with two water passages near to the distributor hole area. If a 'UB' type cylinder head is fitted to a later engine block, the correct original DK4A (as fitted to 'UB' engines) distributor drive dog together with the 'shorter' shaft to which it connects, will have to be fitted otherwise it may not pass into the 22mm diameter cylinder block hole and the distributor will not fit low enough; however provided that is done, either the 'UB' type gasket or the 'Series E' type gasket will actually fit in place; but as will be noted later, as I understand it neither are satisfactory in this instance.

- If the earlier gasket (Series I / II diagram; Payen AA 680) is used, the coolant will be diverted via the water passage between cylinders 2 and 3 and will enter the cylinder head satisfactorily. But there is a chance that the larger distributor aperture in the gasket could lead to potential failure at the water passages near to the distributor hole.
- If the later gasket (Series E diagram; Payen AA 250) is used, coolant will be blocked (it cannot be diverted in this area) from entering the cylinder head via the water passage between cylinders 2 and 3, and this is likely to cause localized overheating and potential failure.
- Surely we need a 'hybrid' earlier/late pattern gasket. In effect a later type (Series E diagram) pattern but incorporating the water passage aperture between cylinder 2 and 3.

- a) UB cylinder head on UB engine block.....use the earlier gasket (Series I / II diagram).
- b) Later cylinder head on later engine block.....use the later gasket (Series E diagram).

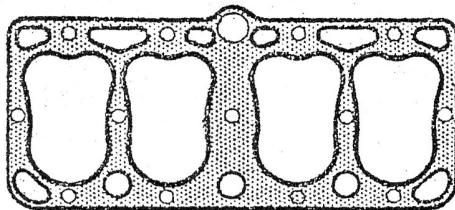
**Morris Eight Series E**

I believe that is important that any gasket on these engines has sufficient 'maximum' width around the distributor aperture. Some I have seen do not, and create a weakness at an important area.

I think a third pattern 'hybrid' gasket in addition to those shown below is required when fitting a UB type cylinder head to a later engine block; in other words a Series E pattern gasket but with an additional water passage aperture between cylinders 2 and 3. Using the Series E pattern gasket with the smaller distributor aperture as the basis is more likely to give a reliable seal at its two adjacent water passages, but even so is not ideal as only the distributor body can attempt to provide a surface to contact the upper face of the gasket. If using a composition gasket (if available and recommended) maybe the gasket can be altered on the bench. Otherwise the gasket manufacturer may need to be asked to make a special copper/asbestos version.
